# INVESTIGATE-DESIGN-BUILD APPROACH LEVERAGES VALUE OF CSO STRUCTURAL FACILITY IMPROVEMENTS FOR GLWA

BY BRIAN GOMBOS, PE, WADE TRIM, AND DENNIS SANSCHAGRIN, PULLMAN

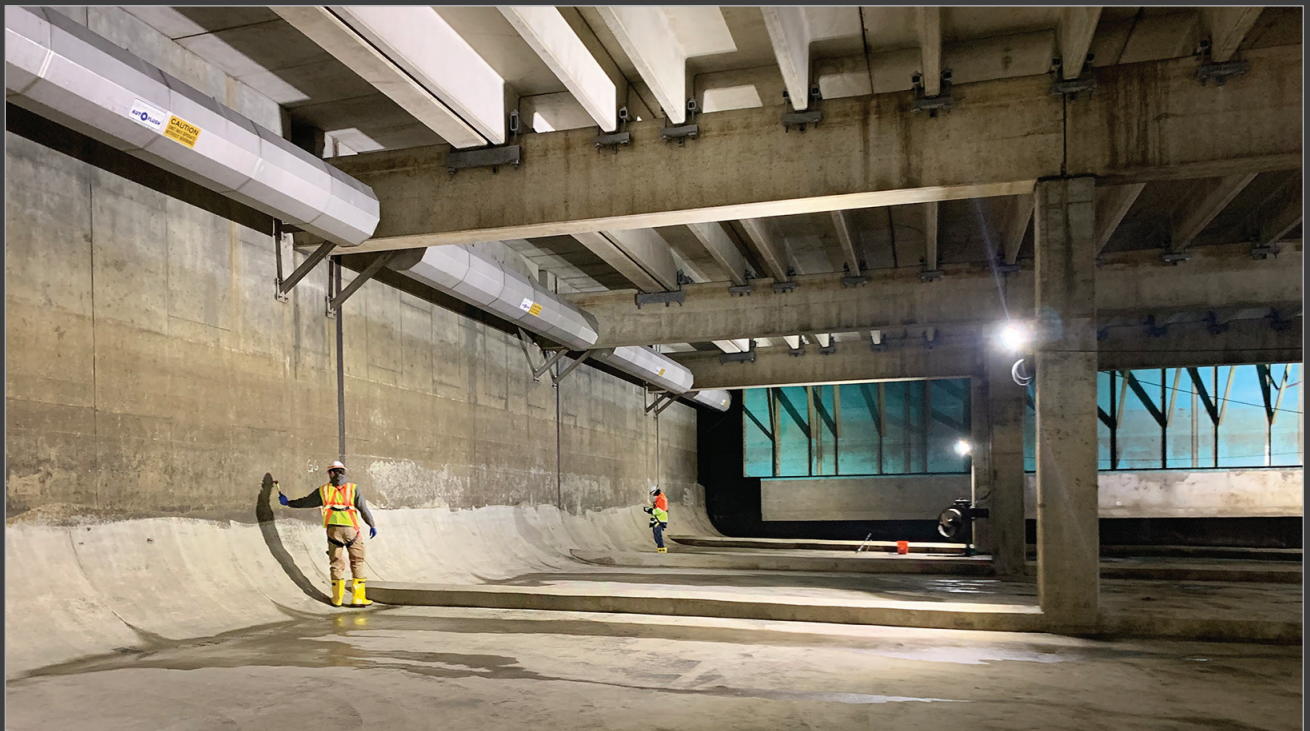
Leveraging a collaborative workflow, experienced structural engineers, and reality capture technology experts, the project team saved GLWA preparation time and cost that otherwise would have been necessary to assess the basins' concrete conditions. Photo courtesy of Wade Trim

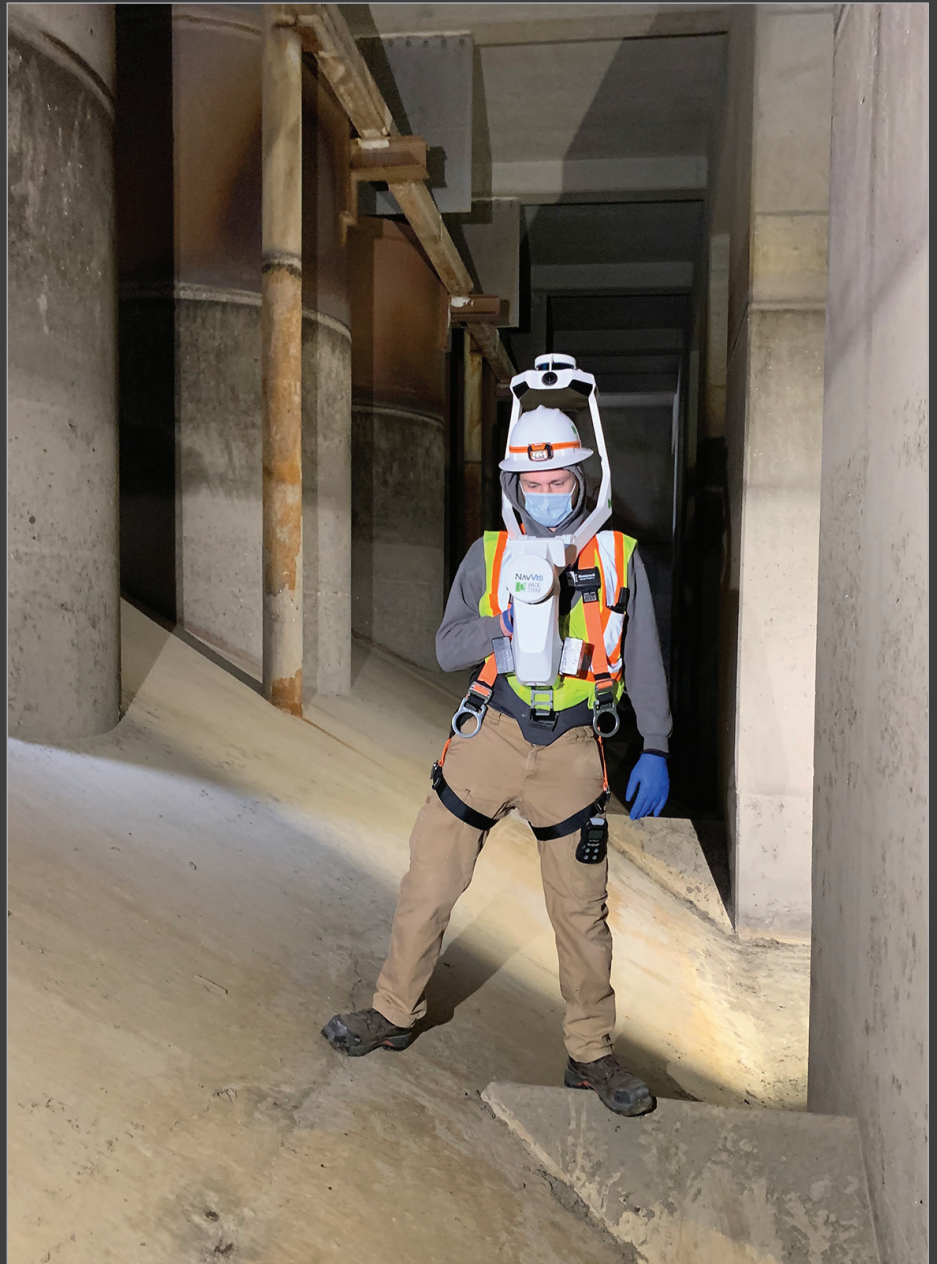
**Reality capture during inspection improved safety and increased data retrieval efficiency in areas with complex geometry and confined space constraints. The information helped facilitate planning and desktop evaluation of existing conditions.** Photo courtesy of Wade Trim

The speed of investigation also got a boost with mobile capture technology. Normal condition assessment typically entails weeks of reporting using paper drawings, cameras, and teams of inspectors. Using a combination of hardware and software data capture, Wade Trim obtained survey-grade digital data for each facility in a few workdays. The drones and mobile capture equipment provided accurate 3D and photographic records of facility conditions including uneven surfaces and difficult to reach corners. The approach dramatically reduced the time needed to complete the structural inspections as well as safety risks for workers.

Mobile capture technology delivered more robust as-built data, eliminating the need for follow-up visits. Full-scale point cloud data and high-definition 360-degree panoramic photographs captured were placed into a "digital twin" environment,

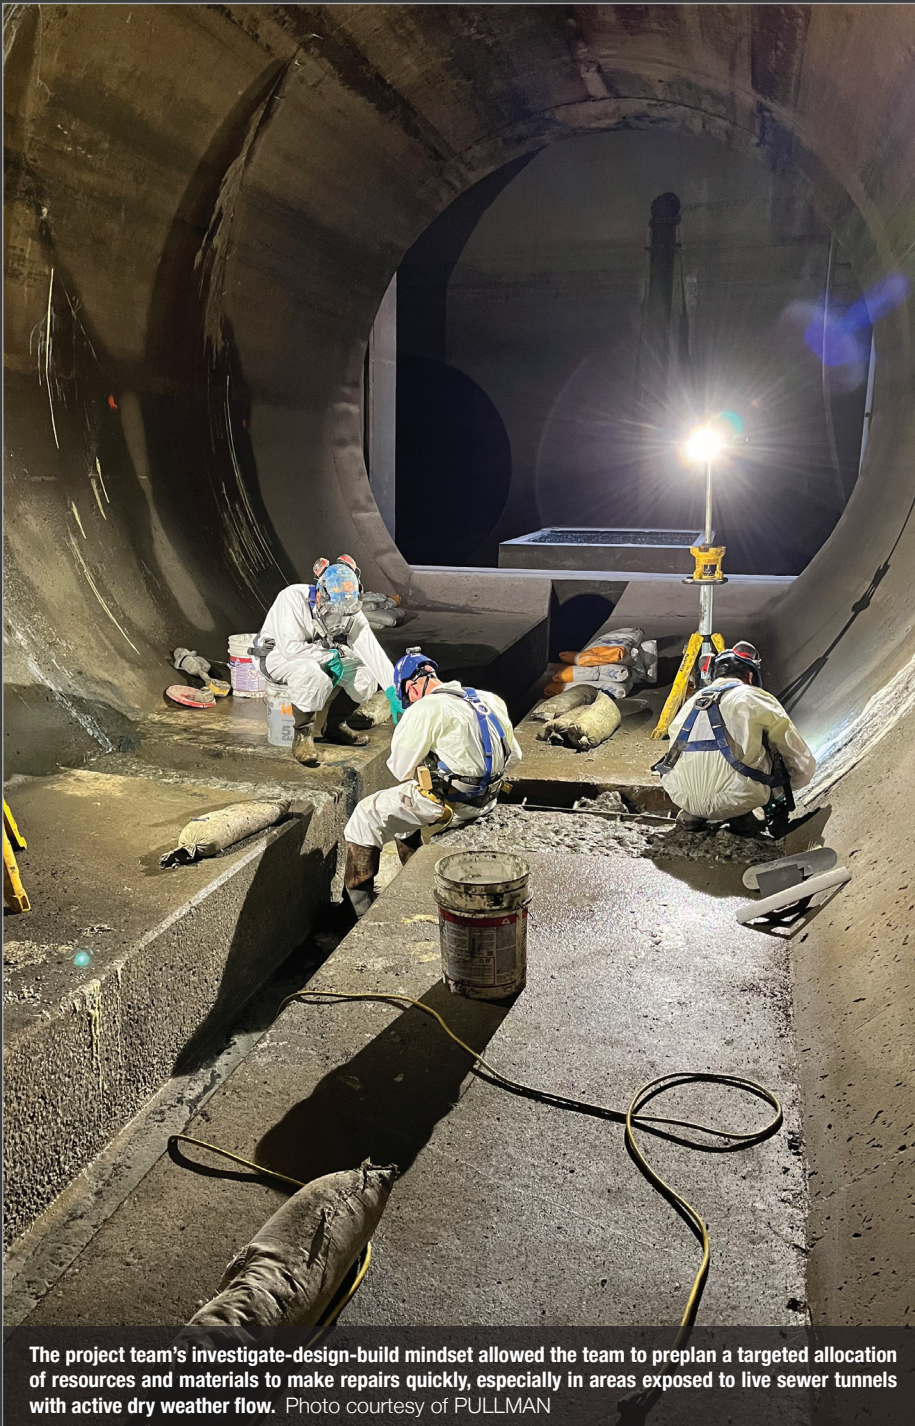
The project team's investigate-design-build mindset allowed the team to preplan a targeted allocation of resources and materials to make repairs quickly, especially in areas exposed to live sewer tunnels with active dry weather flow. Photo courtesy of PULLMAN

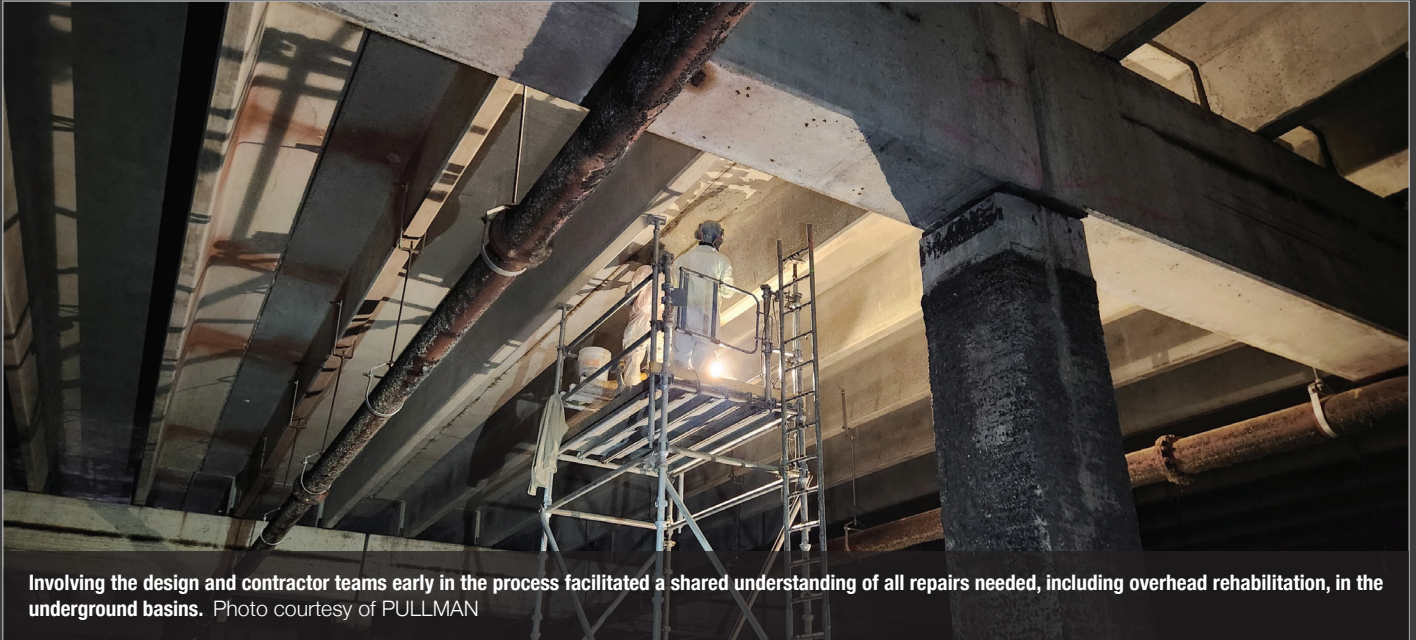
Involving the design and contractor teams early in the process facilitated a shared understanding of all repairs needed, including overhead rehabilitation, in the underground basins. Photo courtesy of PULLMAN

Value can also be found in the quality of repairs. The majority of concrete repair work consisted of crack injections (structural and non-structural), spall and delamination repairs, and joint sealants. As design engineer, Wade Trim had representation in the field alongside PULLMAN to observe repair methods and confirm quality, and worked closely with the contractor to adapt
