Bellevue Biltmore Resort

Clearwater, Florida

SPAR 2008

R. J. Heisenbottle Architects, PA

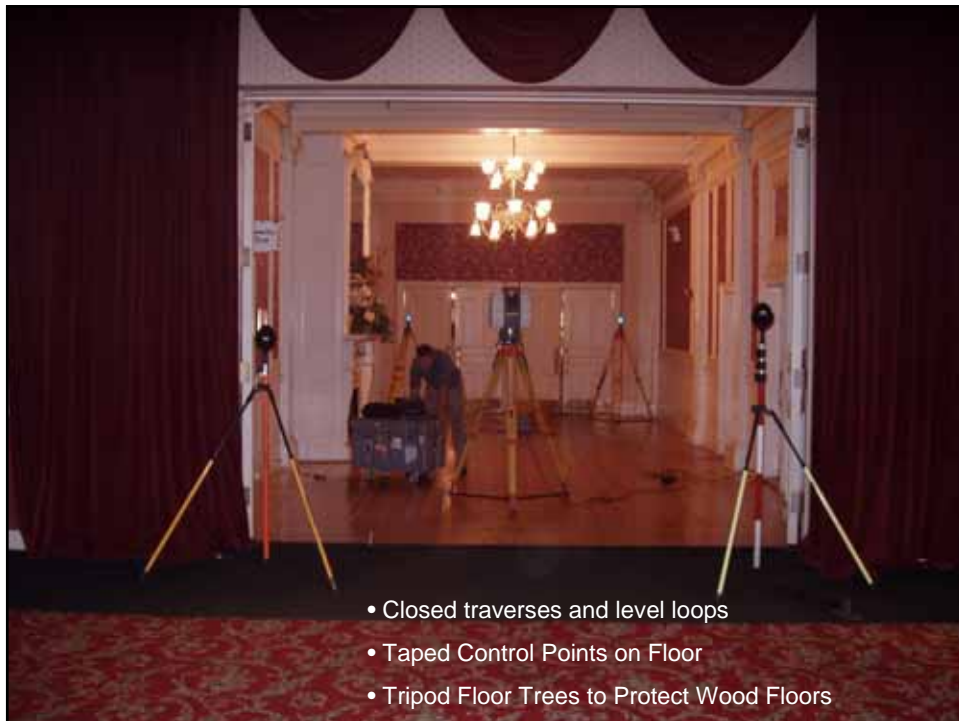
- Closed traverses and level loops
- Taped Control Points on Floor
- Tripod Floor Trees to Protect Wood Floors

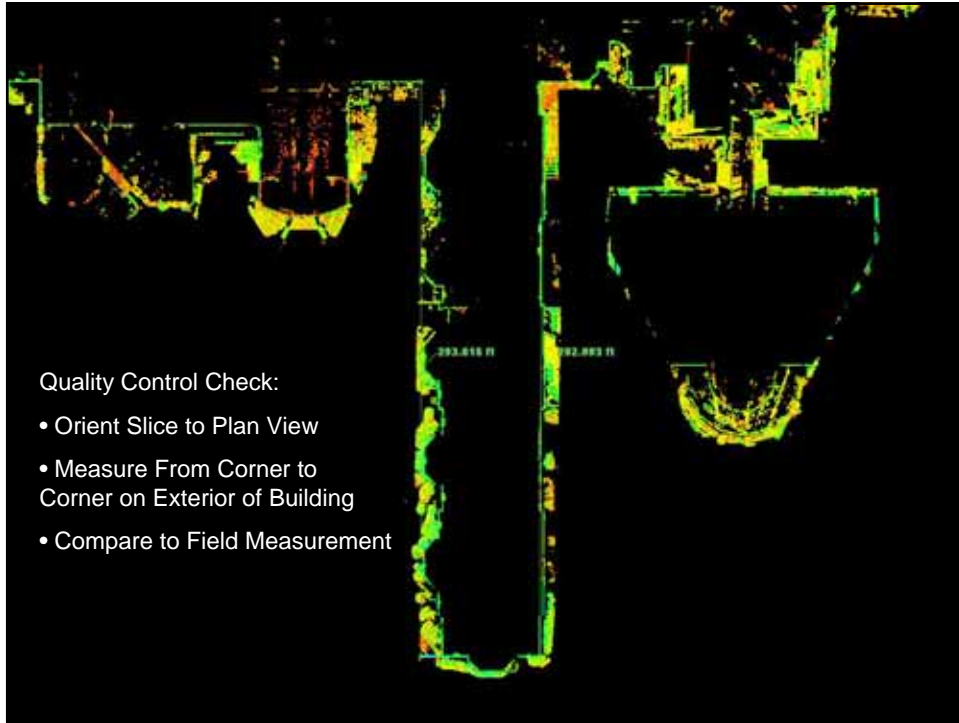
Quality Control Check:

- Orient Slice to Plan View
- Measure From Corner to Corner on Exterior of Building
- Compare to Field Measurement

Distance checks on South Wing of Hotel

Scanned Distances for overall length (north to south) of South Wing
(See Exhibit A - .jpg picture)

Surveyed distances by total station and Electronic Distance Measurement (EDM) for overall length (north to south) and distances to bay windows from southwest corner
(See Exhibit B – Survey sketch) (Also see Exhibit C - .jpg picture for illustration of where distances were measured to on the bay windows.

Scanned horizontal distance from southwest corner to northwest corner	- 293.02'
Surveyed overall distance by total station / Electronic Distance Measurement)	- 292.96'
Scanned horizontal distance from southeast corner to northeast corner	- 292.99'
Overall distance on east side of South Wing from Southeast Corner to northeast corner from survey drawing (fp-polygon-00.dwg)	- 293.1'

For distance comparisons from Southwest corner of South Wing to the Bay windows see Exhibit B.
